RETRACEMENT AND
TOPOGRAPHIC SURVEY OF THE
TRUSTEES OF M.E. CHURCH AND
TRUSTESS OF THE METHODIST CHURCH
OF BELLE CENTER, OHIO
LOT 46 AND LOT 45
ORIGINAL PLAT OF BELLE CENTER
PLAT CABINET A, SLIDE 104
VOLUME 49, PAGE 337 AND
VOLUME 209, PAGE 265
VILLAGE OF BELLE CENTER
RICHLAND TOWNSHIP
COUNTY, OHIO

SURVEYED BY:
William K. Bruce
WILLIAM K. BRUCE
PROFESSIONAL SURVEYOR 7437
DECEMBER 12, 2008

RETRACEMENT SURVEY OF THE
HERSCHEL CUMMINGS AND
VERA DEMARSH
PART OF LOT 61
ORIGINAL PLAT OF BELLE CENTER
PLAT CABINET A, SLIDE 103
OFFICIAL RECORD 1194, PAGE 273
VILLAGE OF BELLE CENTER
RICHLAND TOWNSHIP
LOGAN COUNTY, OHIO

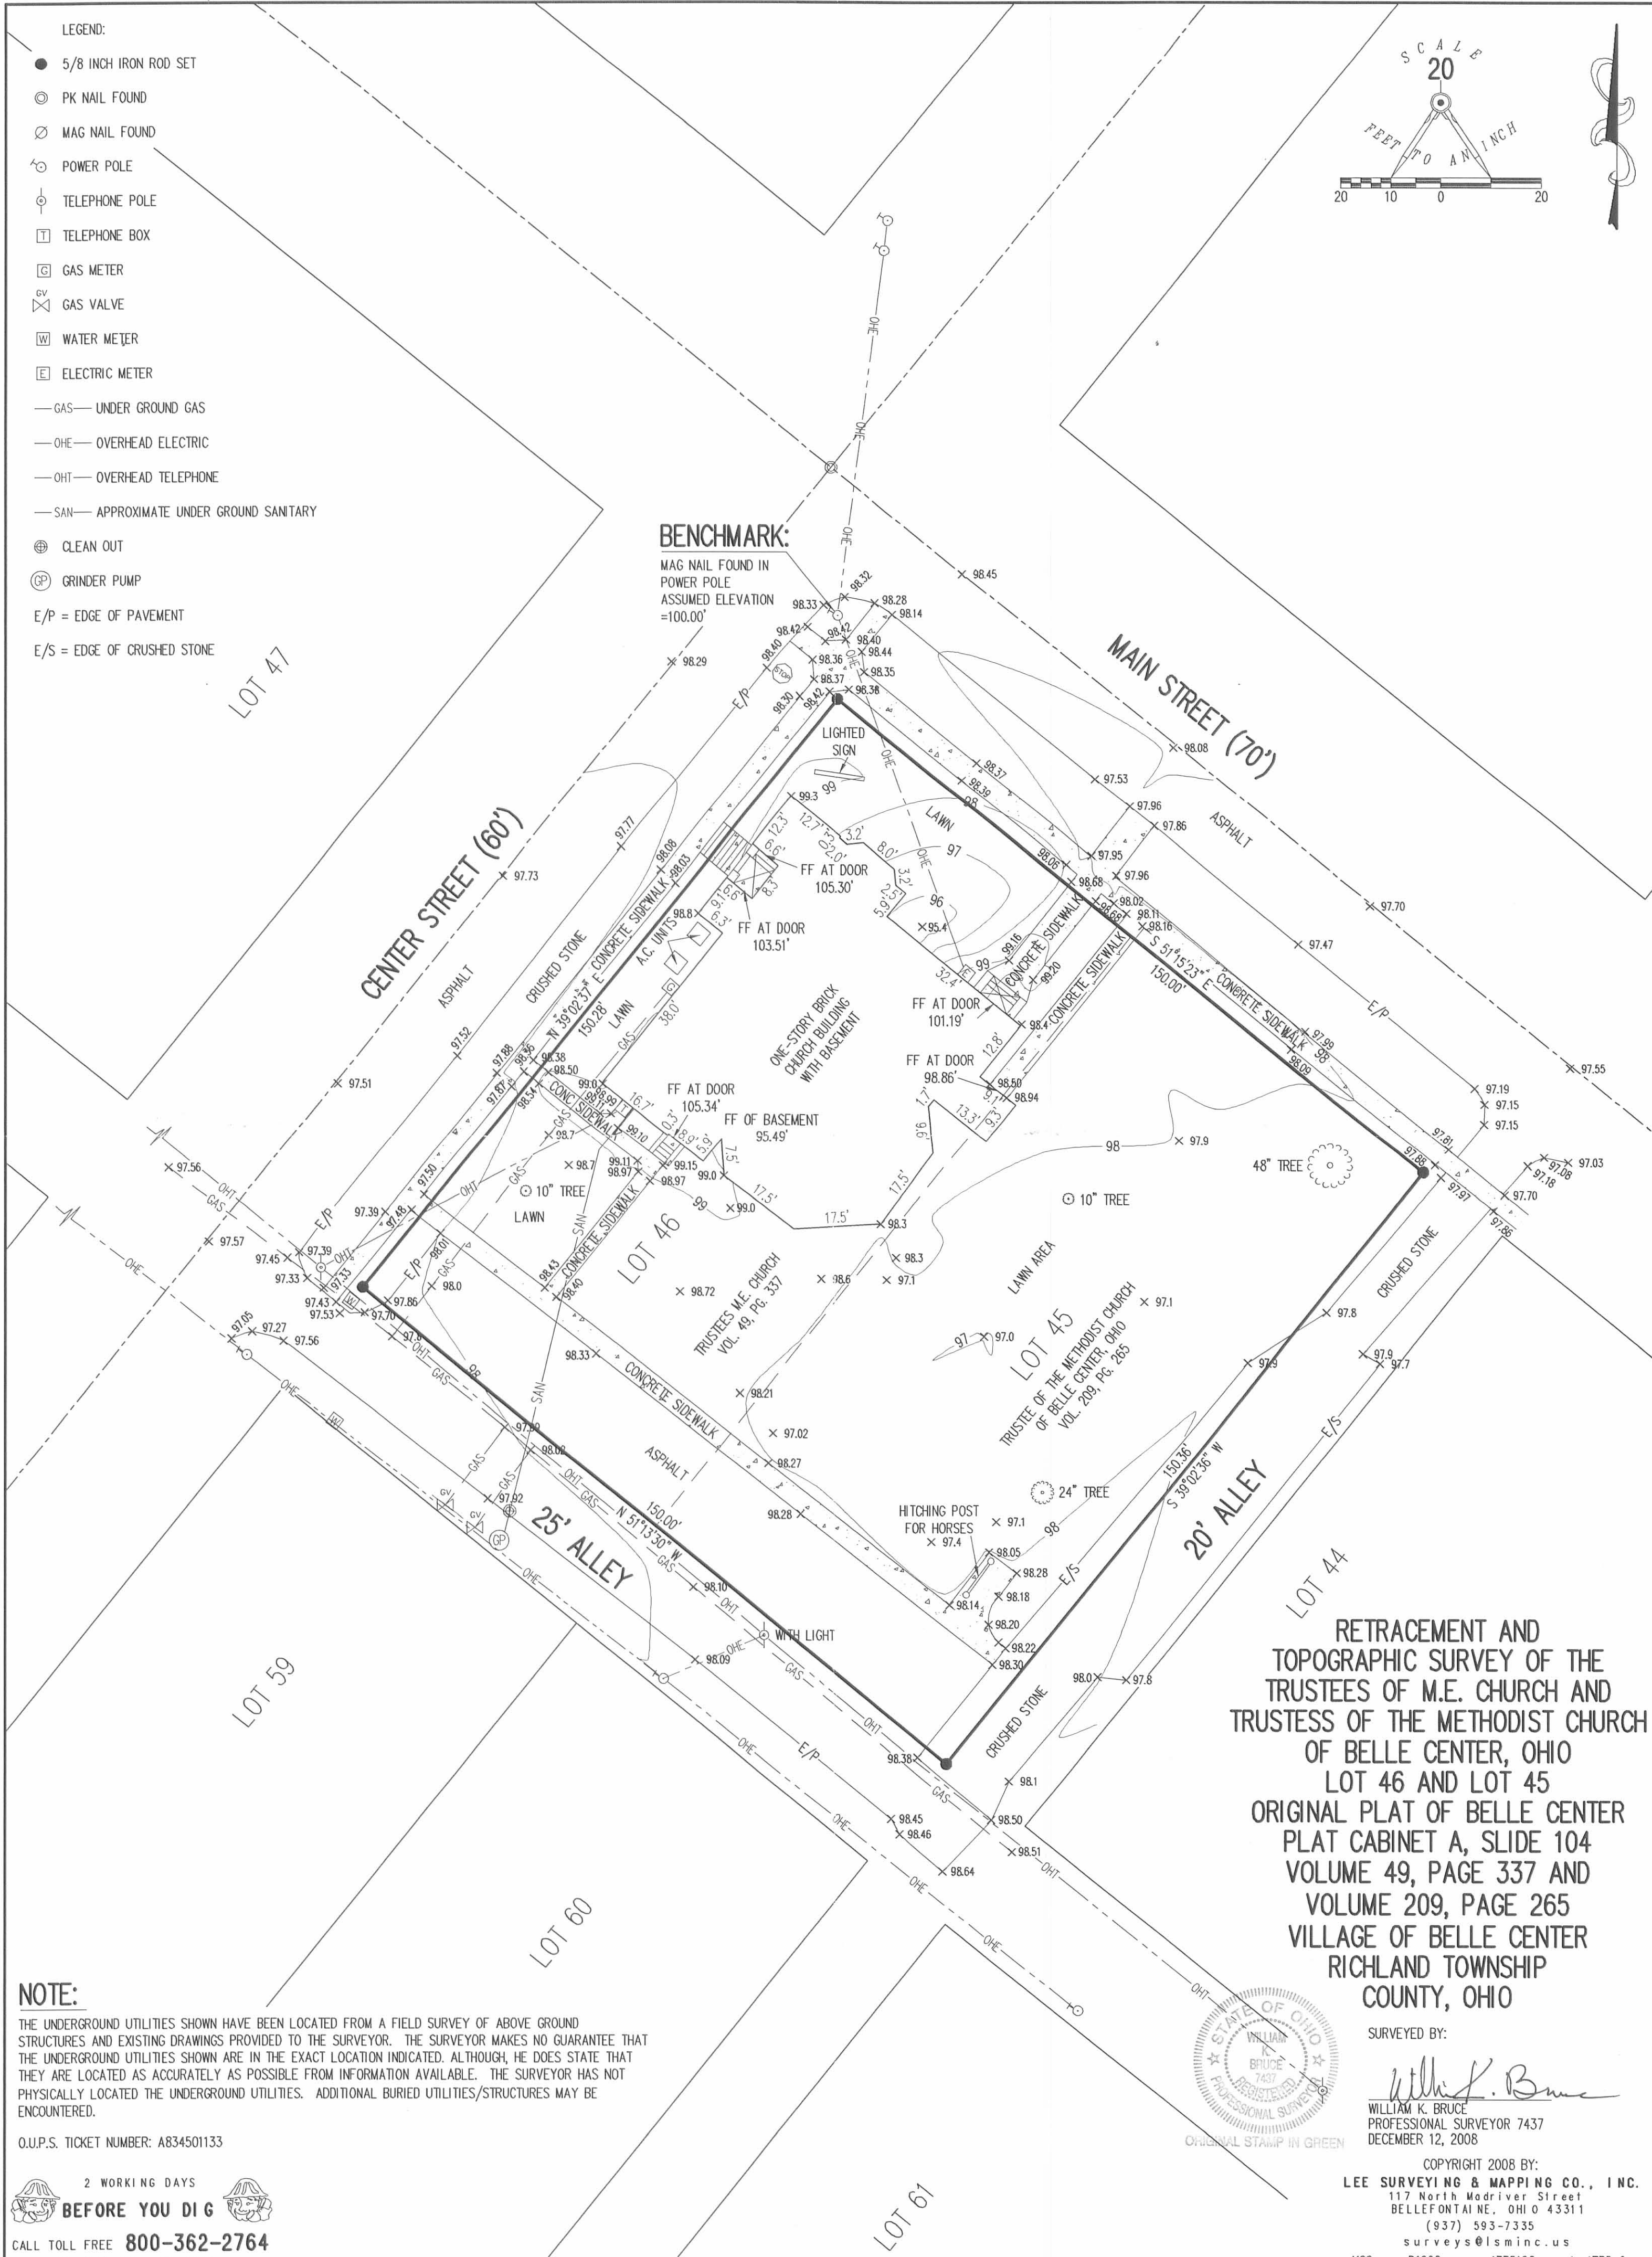
MAG NAIL FOUND IN
POWER POLE
ASSUMED ELEVATION
=100.00'

NOTE:
THE UNDERGROUND UTILITIES SHOWN HAVE BEEN LOCATED FROM A FIELD SURVEY OF ABOVE GROUND STRUCTURES AND EXISTING DRAWINGS PROVIDED TO THE SURVEYOR. THE SURVEYOR MAKES NO GUARANTEE THAT THE UNDERGROUND UTILITIES SHOWN ARE IN THE EXACT LOCATION INDICATED. ALTHOUGH, HE DOES STATE THAT THEY ARE LOCATED AS ACCURATELY AS POSSIBLE FROM INFORMATION AVAILABLE. THE SURVEYOR HAS NOT PHYSICALLY LOCATED THE UNDERGROUND UTILITIES. ADDITIONAL BURIED UTILITIES/STRUCTURES MAY BE ENCOUNTERED.

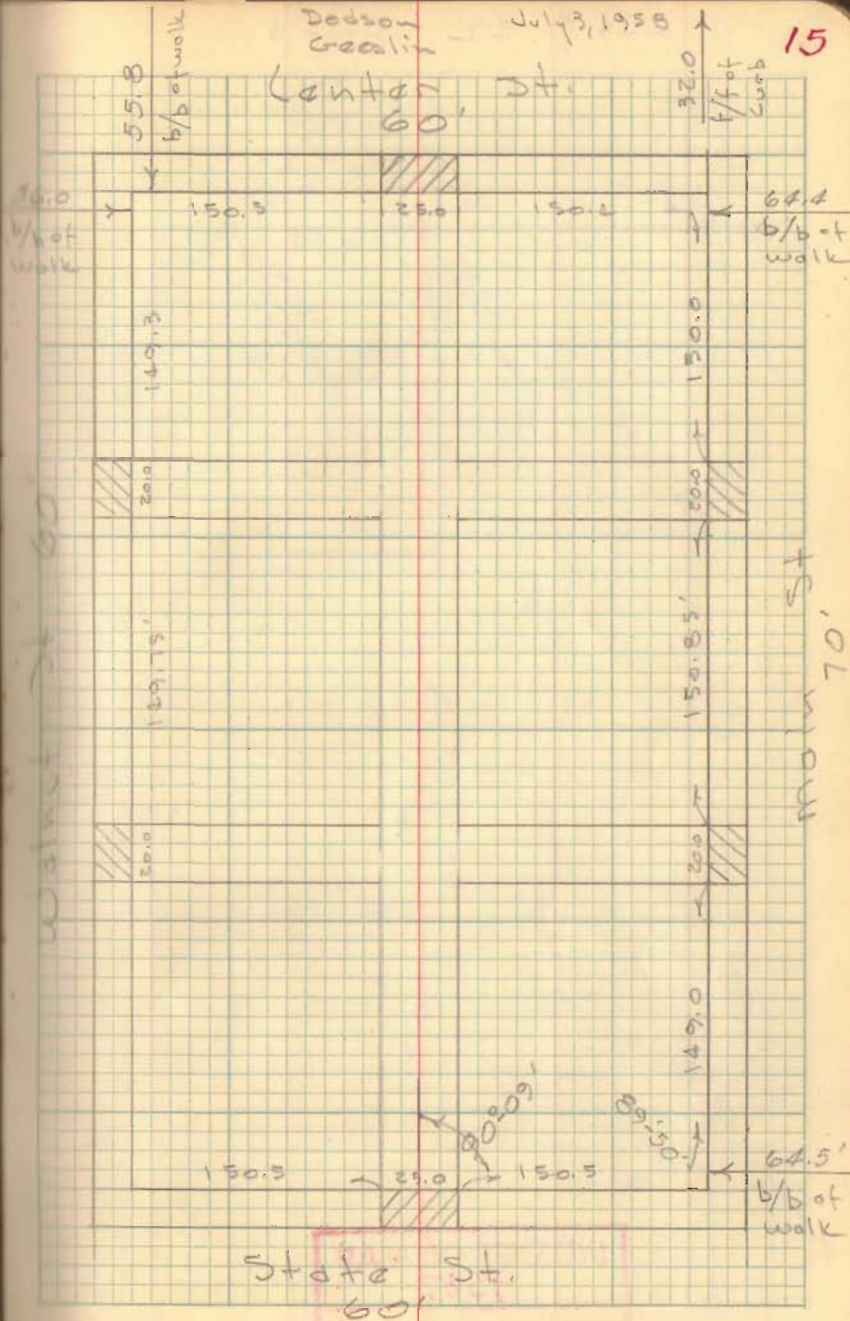
15

lot # 42, except 45' off of North

lots 75x.150

On	From	To	Dist	Plot	±
Center	Main	Walnut	325.9	325.0	+0.9
main	Center	State	490.0	490.0	0
State	main	Walnut	326.0	325.0	+1.0'
Walnut	State	Center	490.0	490.0	0

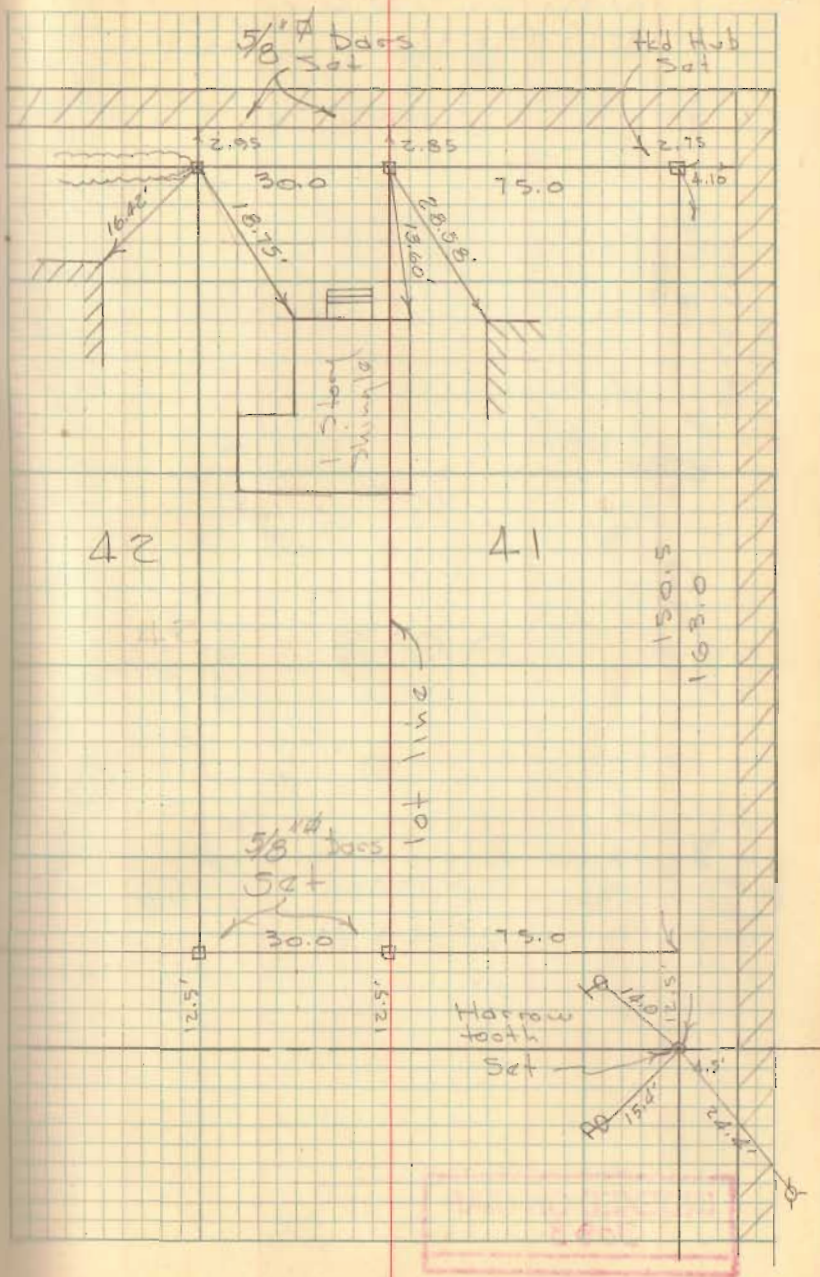
16

Lot # 42 Cont'd
