FB 713

C.R. 4A  
Miami Township  
Logan Co., Ohio

INDEXED ON MAP  
1804

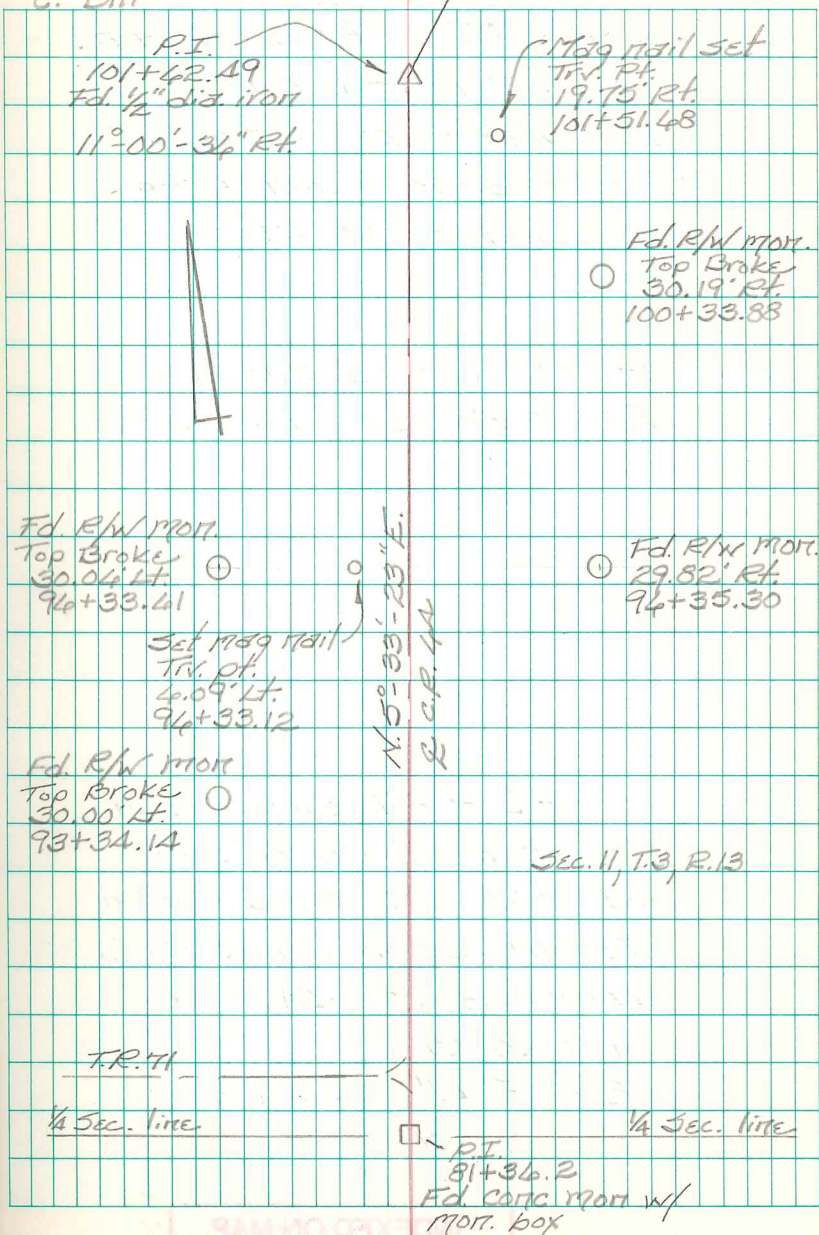
70

101+42.49 - P.I. - Found 1/2" dia  
iron bar w/ top bent - this  
iron was in bad shape so  
we replaced it with a 5/8"  
dia. capped iron bar stamped  
"Logan County Engineer."  
Shown as Sta. 20+28 on pg. 3  
of 1935 Brg. 43-2.30 plans.  
Ref: F.Bk. # 403, pg. 45.  
11°-00'-34" Rt.

81+36.2 - P.I. - Fd. concrete mort. in  
mort. box - Center of Sec. 11,  
T.3, R.13 - The monument box  
was in bad shape so we  
repaired it. - Start of  
this survey.  
Ref: F.Bk. # 403, pg. 43 &  
pg. 77

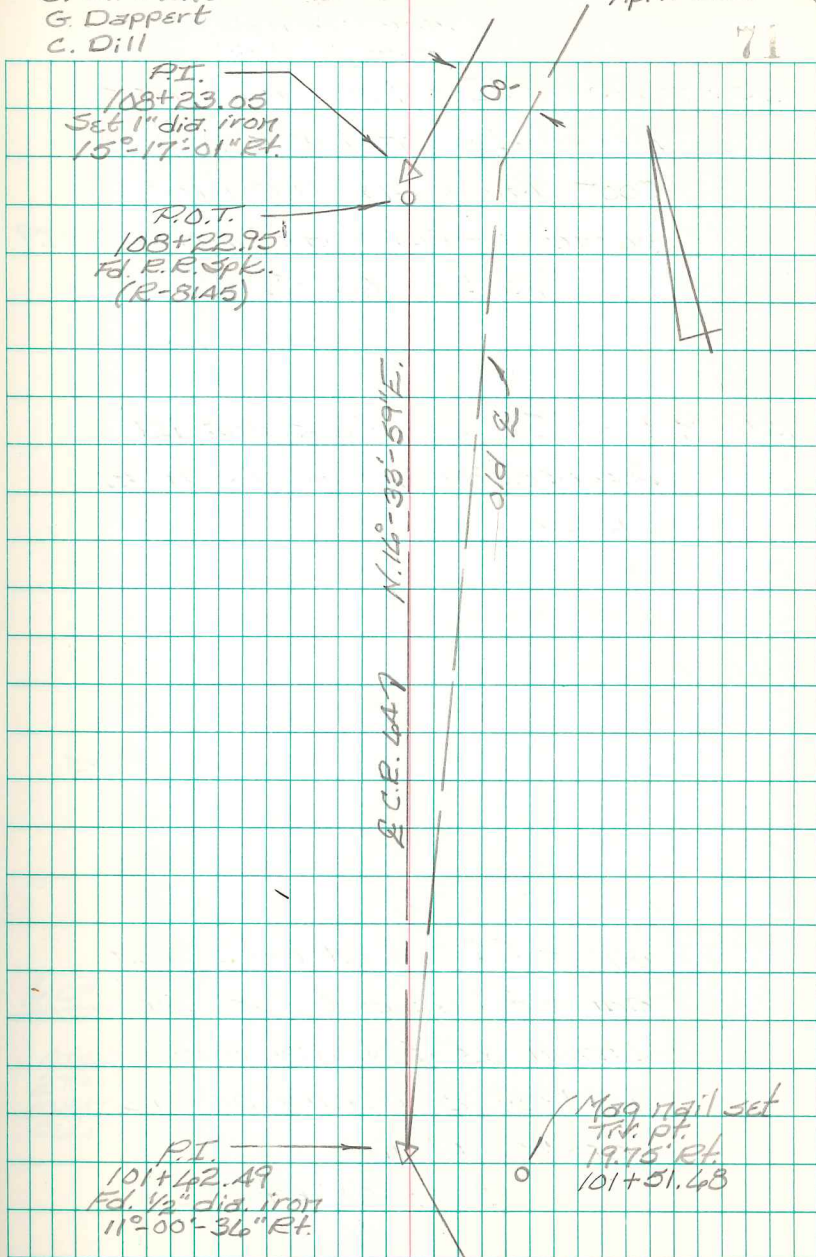
71

108+23.05 - P.I. - Set 1" dia. iron bar -  
Fd. a 1" dia. iron bar here in  
2007 which was destroyed  
during bridge construction.  
15°-17'-01" Rt.

108+22.95 - P.O.T. - Fd. R.R. Spike -  
Apparently set during recent  
survey.

101+42.49 - P.I. - Fd. 1/2" dia. iron bar  
w/ top bent - This iron was in  
bad shape so we replaced it  
with a 3/8" dia. capped iron bar  
stamped "Logan County Engineer."  
Shown as Sta. 20+28 on pg. 3  
of 1935 Brq. 43-2.30 plans.  
Ref: F.Bk. # 403, pg. 45.  
11°-00'-36" Rt.

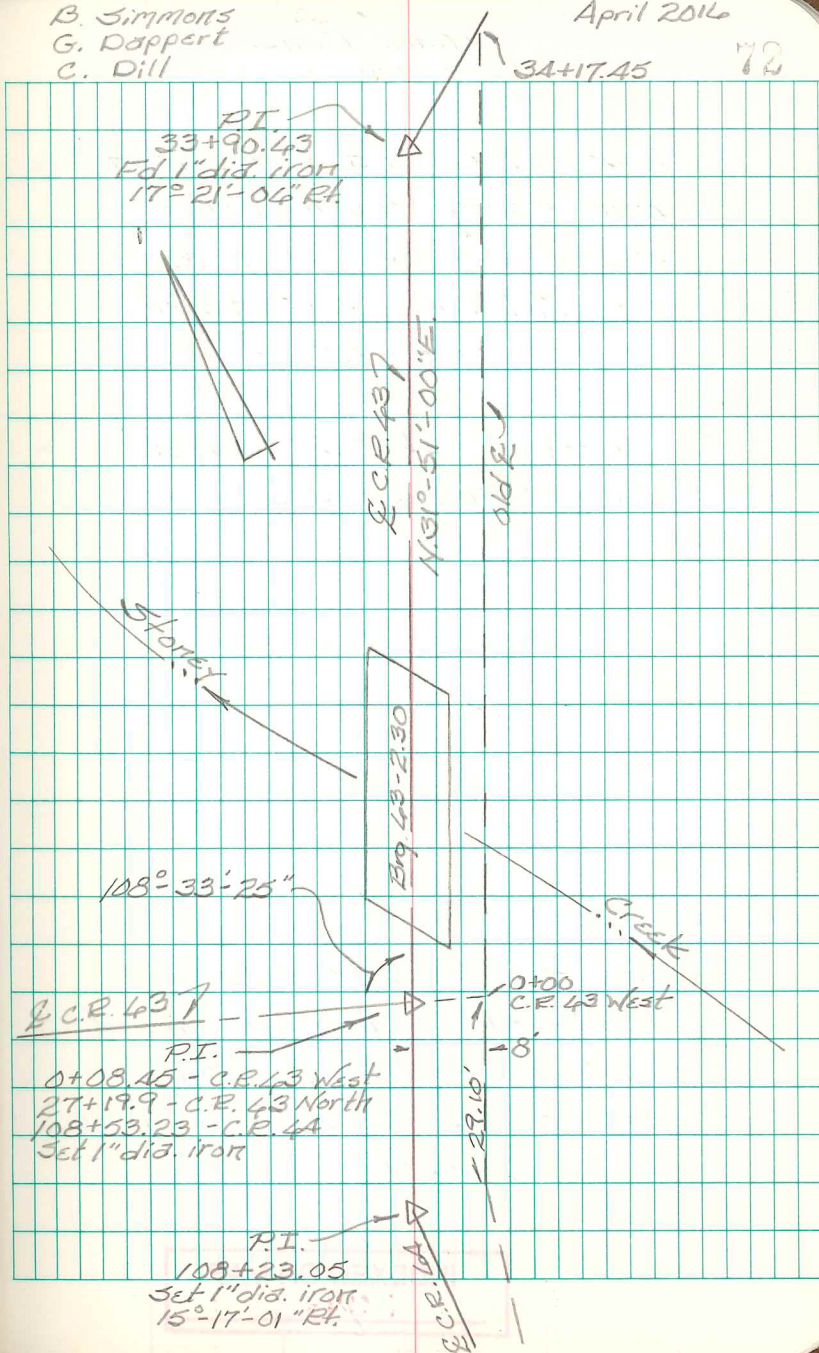
72

33+90.43 - P.I. - Fd. 1" dia. iron  
bar. - Set this iron bar in  
2007 using R/W monuments  
found - Shown as Sta. 33+87.9  
on 1935 Brq. 43-2.30 plans.  
17°-21'-06" Rt.

27+19.9 - P.I. - Set 1" dia. iron bar -  
Intersection of C.R. 43 w/ of  
C.R. 44 - Fd. a 3/4" dia. iron  
bar here in 2007 which was  
destroyed during bridge  
construction.

108+23.05 - P.I. - Set 1" dia. iron  
bar - Fd. a 1" dia. iron bar  
here in 2007 which was  
destroyed during bridge  
construction.

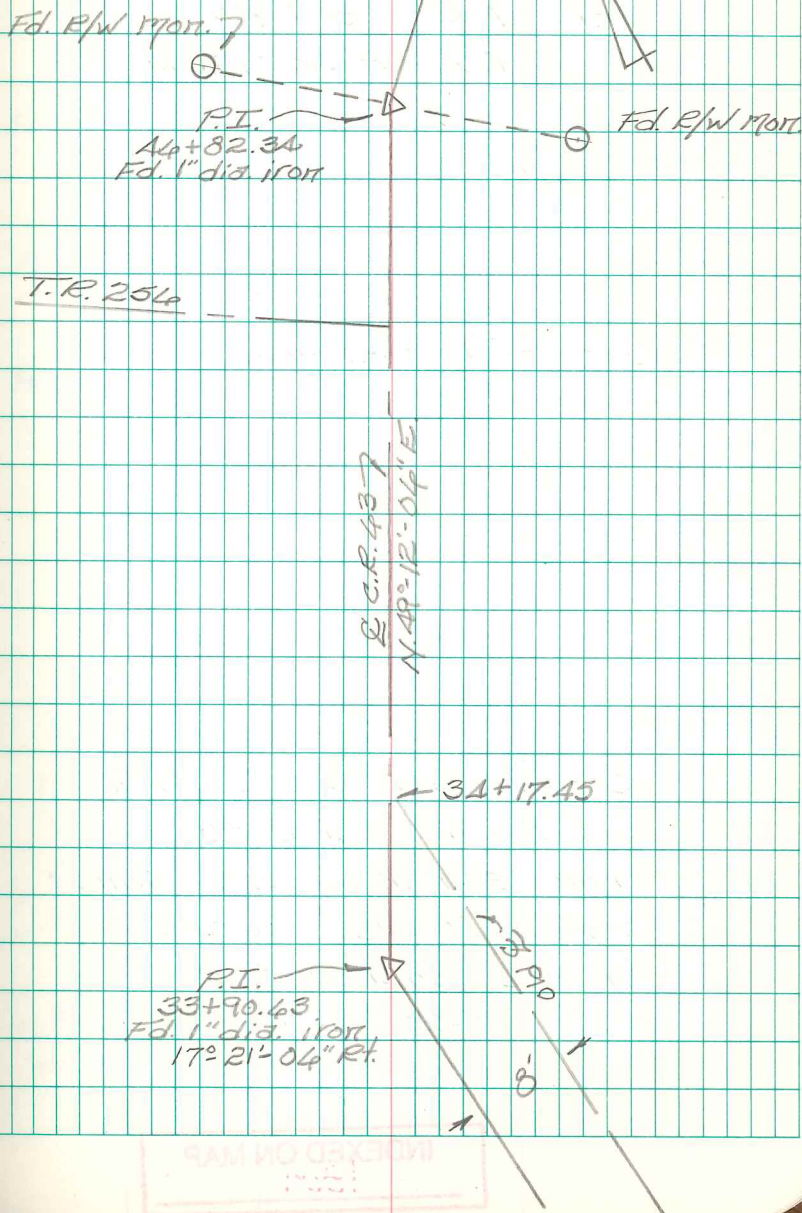
73

46+82.34 - P.I. - Fd. 1" dia. iron  
bar - Dug here in 2007 in  
search of hub - No luck -  
Set 1" dia. iron bar on split  
of R/W monuments found at  
that time. - Shown as Sta.  
46+81 in F.Bk. #587, pg. 41. -  
End of this survey.

33+90.43 - P.I. - Fd. 1" dia. iron bar -  
Set this iron bar in 2007  
using R/W monuments found -  
Shown as Sta. 33+87.9  
on 1935 Brq. 43-2.30 plans.  
17° 21' 04" Rt.

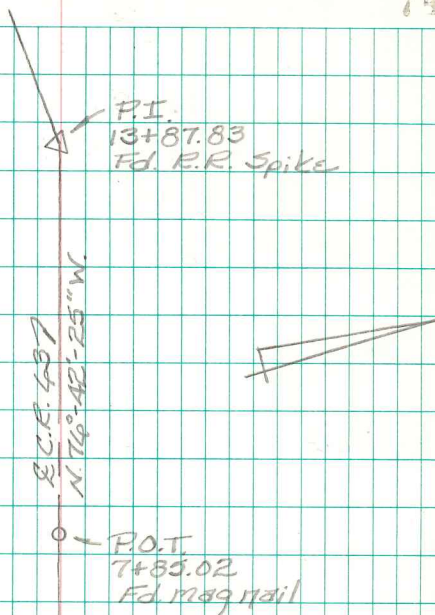
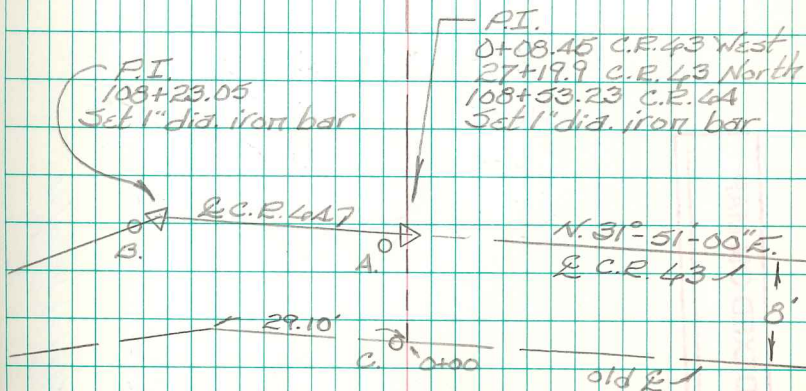
74

13+87.83 - P.I. - Fd. R.R. Spike -

7+85.02 - P.O.T. - Fd. mag nail -

0+08.45 - P.I. - Set 1" dia. iron bar -

Intersection of C.R. 43 w/  
of C.R. 44 - Fd. of 3/4" dia.

iron bar here in 2007 which  
was destroyed during  
bridge construction

Pt. A - Fd. mag nail  
0.07' E.  
108+53.16  
(E-8145)

Pt. B - P.O.T.  
Fd. R.R. Spk.  
108+22.95

Pt. C - Fd. mag nail  
8.05' E.  
27+22.52
